UPPER DONIPHAN DAM  
RAY COUNTY, MISSOURI  
MO 12091

PHASE 1 INSPECTION REPORT  
NATIONAL DAM SAFETY PROGRAM

Name of Dam	Upper Doniphan Dam
State Located	Missouri
County Located	Ray County
Stream	Lick Creek
Date of Inspection	2 December 1980

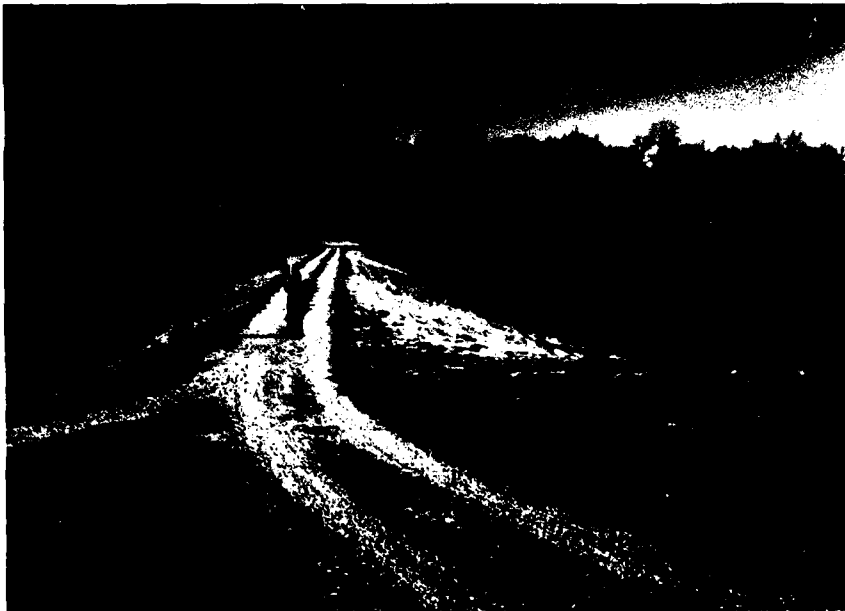
The dam crest has a grass and gravel road cover with some worn spots, probably due to foot and vehicle traffic. Wave action erosion was observed on the upstream slope. There is no riprap protection for this dam.

PHOTO 3: CREST OF DAM LOOKING EAST
